Action Research
**Re-enforcement of Mud Grain Storage
and Mud Houses**

Mercy Corps Nepal
Kailali Disaster Risk Reduction Initiatives - II
July 2010

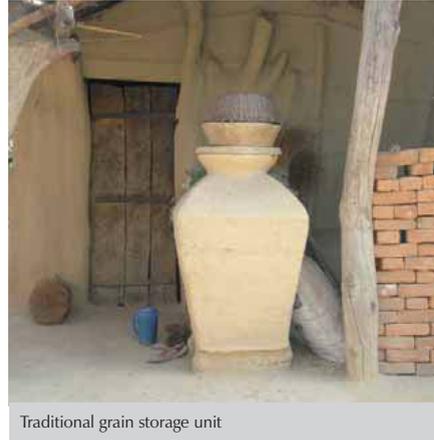
Traditional grain storage unit

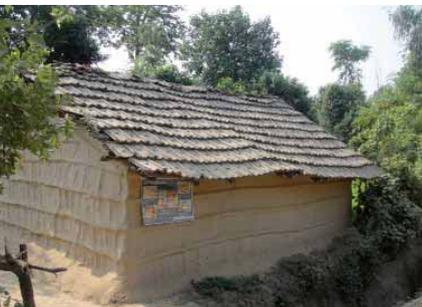
Traditional mud house

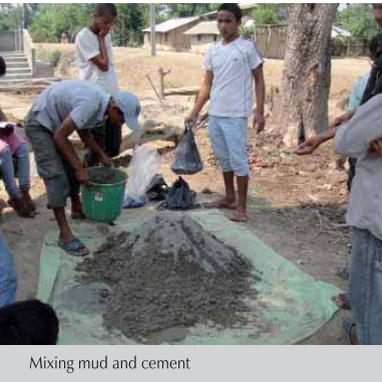
Mixing mud and cement

- a) 1 bucket (0.75 cu. ft.) of mud generally used by local communities for plastering mud houses was used. The mud was crushed and sieved through a screen to remove organic matter and debris.
- b) As this soil consisted mostly of clay particles, an equal amount of sand (1 bucket) was also sieved and mixed with the mud to raise the sand content to 50%.
- c) 3.1 kg (5% by vol.) of cement was added to mud and mixed thoroughly.
- d) 1/2 bucket (25% by vol.) of water was added and mixed to make paste-like mortar.
- e) Loose particles and irregularities were scraped off from the mud wall with a broom.
- f) The wall was moistened by sprinkling water. The water was allowed to be soaked up by the wall and water was sprinkled again.

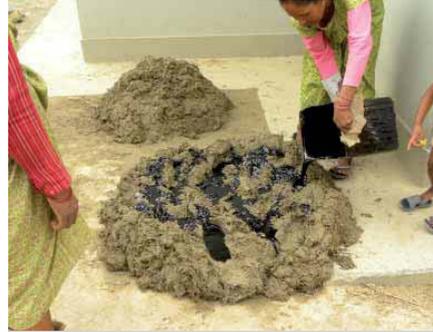
Mixing mud and bitumiin

- a) 2 buckets (1.5 cu. ft.) of mud was mixed with 2 buckets (1.5 cu. ft.) of fine sand to obtain mud with 50% sand and 50% clay.
- b) Water was added to the mud and kneaded to obtain a uniform paste.
- c) 5.5 kg of wheat straw (bhusa) chopped into 20mm lengths was added to the mud paste and kneaded until the bhusa was distributed uniformly.
- d) The mix was kneaded twice daily for 7 days to decompose the straw. Water was added while kneading to prevent the mix from drying.
- e) 10 kg of 80/100 grade bitumen was taken in a barrel and heated till it melted.
- f) The molten bitumen was poured into another barrel containing 2 litre of kerosene with constant stirring to prepare cut-back bitumen.

- g) 5 kg of the cut-back bitumen was mixed with the mud and straw mixture prepared earlier and kneaded to obtain a uniform mix.
- h) Mud walls were moistened by sprinkling water. Water was allowed to be soaked by the all and moistened again.
- i) The NEM plaster was applied on the mud wall up to 3' height from the ground. The plaster of about 12 mm thickness was applied with hand by starting from the top and proceeding towards the bottom. This mixture was used to plaster 1 wall of the hut and a deheri.
- j) The plaster was allowed to dry for 3 days. Cracks were not visible in the plaster.
- k) Stabilized mud slurry was prepared by mixing $\frac{1}{2}$ bucket mud and $\frac{1}{2}$ bucket cow dung with water to make uniform paste. 1.5 kg of cut-back bitumen was added to the mixture.
- l) The slurry was applied over the NEM plaster to give the plaster a smooth finish.

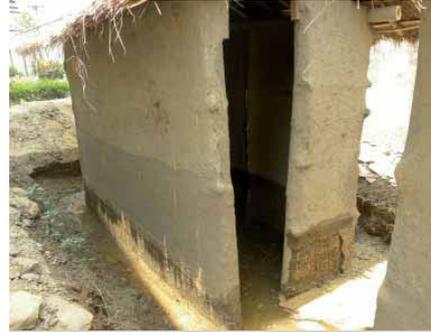
NEM plastered versus traditional mud plaster tested for water resistance. Bitumin NEM to the left.JPG

- There was considerable damage done by water to the walls which were not plastered. The mud plaster was eroded and the bamboo and khariyo in the walls were exposed slightly.

- No damages were visible in the walls plastered with bitumen based NEM.
- The deheri and kotali plastered with bitumen based NEM were intact and the insides were dry.

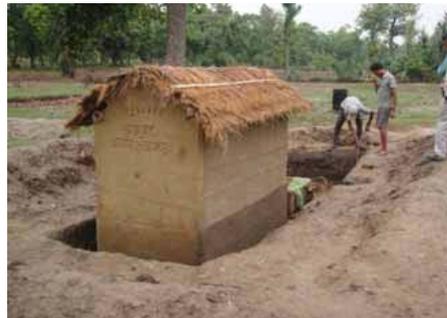
Plastering of Model Hut

A model hut similar to the one built for the research work had been constructed in a trench to demonstrate the performance of the plasters after flooding for 24 hours. The training was conducted for all of the three different types of the plasters (viz. bitumen based, cement based and cement-lime based plasters). The participants were actively engaged in the preparation of the plaster mixtures and its application in the model hut and the two deheris. The three different plasters were applied to the three faces of the hut, whereas one face was left without the NEM plaster. Similarly two deheris were also plastered with bitumen and cement-lime based plasters.

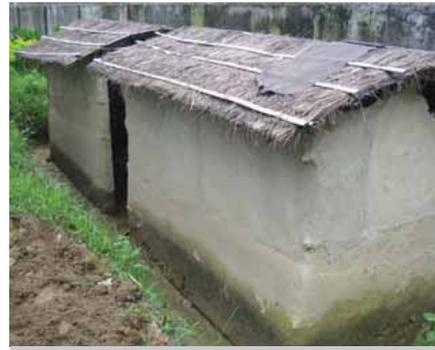
Completed Model Hut

The most important outcome of the training and application is that the community was able to witness the behavior of the walls of the model huts. The results were observed over three months (monsoon season) and communities were able to see the results themselves. As the huts were constructed in trenches they were regularly “flooded” during these months. The bitumen and the cement-lime based plasters remained totally intact and no damage were observed.
